Manhole Inspection Summary

Manhole # S57C__017MH

Insp Date: **6/25/08 2:04 PM**

Location Address: **45 n kresson st**

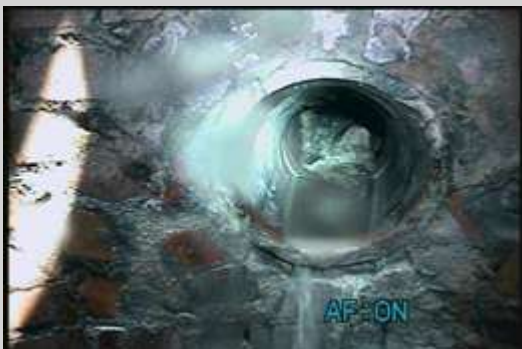
3 O'Clock Inflow

8 in. Circular Gravity Sewer
Pipe In @ 3 OClock

Drop In @ 3 OClock

Invert Depth: 6.42 (ft.) Flow Characteristics: Slow

Deposits: ☒ None ☐ Mud ☐ Sludge ☐ Debris ☐ Grease

Drop: Outside Direct

Inv Depth: 11.21 (ft.)

Drop Condition: Open

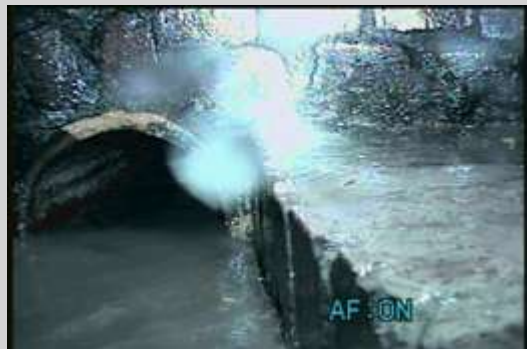
7 O'Clock Inflow

8 in. Circular Gravity Sewer

Pipe In @ 7 O'Clock

Infiltration: **None** Pipe Seal Cond: **Unknown**
